City of Summit

# Road Rating System

## Primer

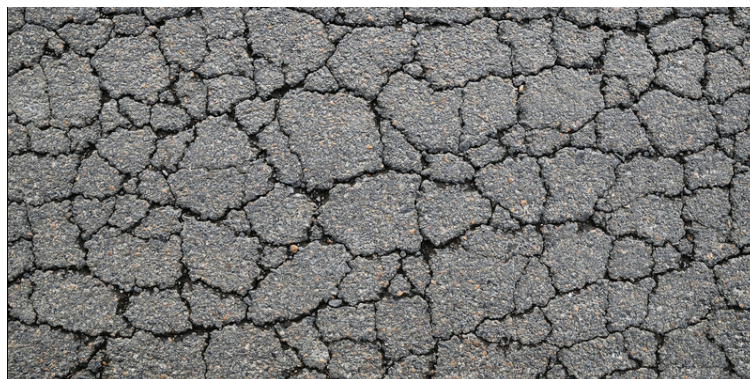
#### Alligator Cracking

This type of cracking is a series of short length cracks caused by failure of the surface asphalt due to repeated loading of vehicles. The cracks start off as large fractures spanning the asphalt in various directions and then overtime connect forming jagged pieces, many sided and sharp angled pieces of asphalt. The resulting appearance of the asphalt is the skin of an alligator.

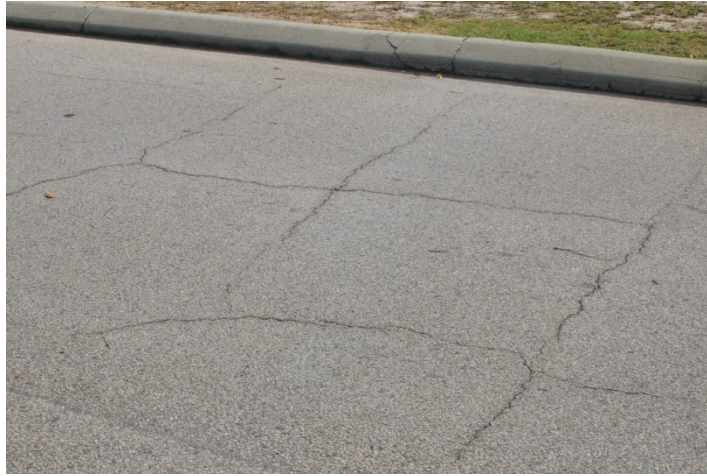
#### Block Cracking

Block cracks create an appearance of large pieces of asphalt. They can range in size from as small as one foot by one foot to 10 feet by 10 feet. The cracks tend to develop over time from over hardening of the asphalt. The cracks can span in various directions and do not only form square pieces. Triangular and multi-sided sections of asphalt can develop as well.

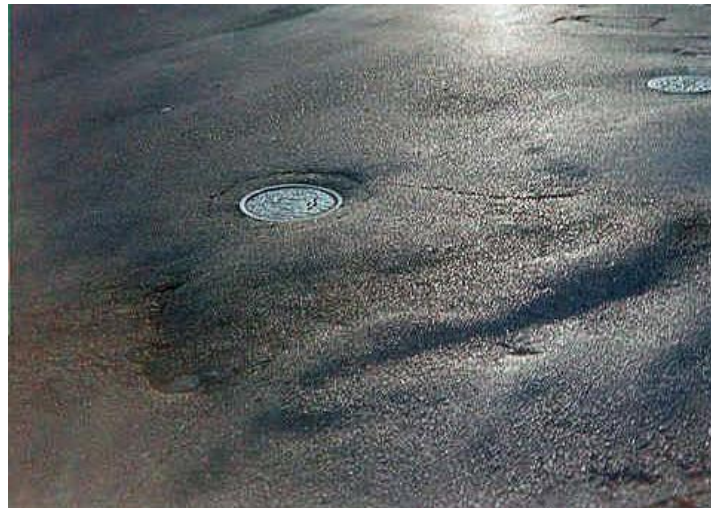
### Distortions

Distortions are defined as bumps or depressions in the asphalt that create displacements and shoving of the asphalt. They are generally localized to specific areas along the road and not seen throughout. This asphalt criterion can be difficult to detect within the City of Summit as the majority of our roads have a very well establish stone base.

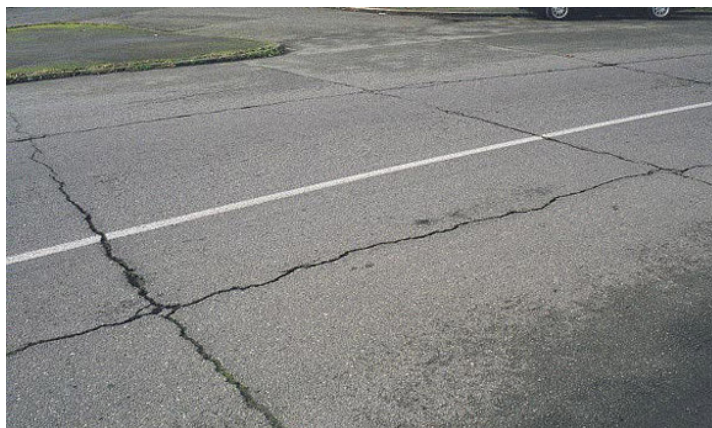
### Longitudinal and Transverse Cracking

These cracks tend to run perpendicular and/or parallel to the road way direction. In most cases, this type of damage is caused by either reflective cracks, cracks of the sub base that cause the surface course to open, or by the expansion joints from a concrete road below the surface course. Additionally, it can be caused by poor joint control during the pavement process.

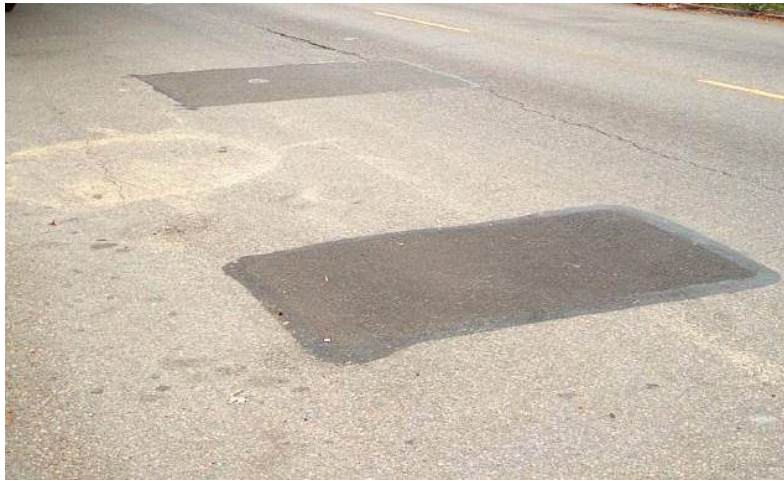
### Patching and Utility Cuts

This criterion is based on utility repairs made below the road surface that are patched with asphalt. In a city like Summit where there are a plethora of underground utilities that are often more than 100 years old, this is a very common occurrence.

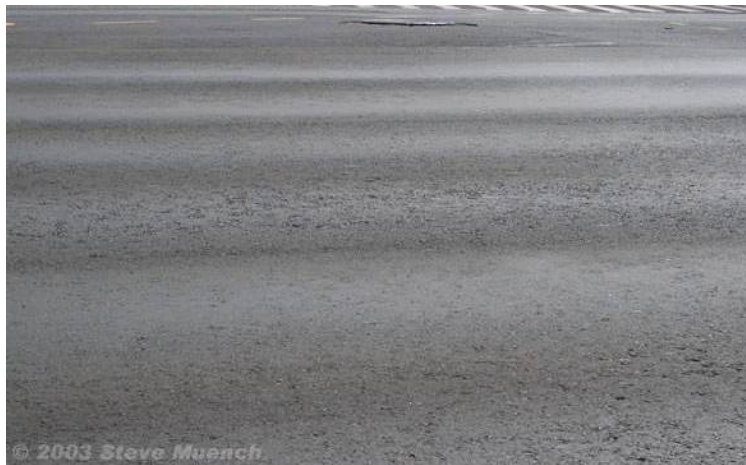
### Rutting and Depressions

Rutting and depressions are a type of settlement that occurs along the wheel path of a road. These settlements are generally caused by over consolidation of the asphalt layers and/or subbase material. Rutting can produce a lateral shift of the asphalt causing the wheels of a vehicle to remain in the grooved path. Generally rutting will occur on streets where there is a constant traffic flow without many stops. Minor cases may sometimes be detected only during rain storms as water tends to puddle in depressions.

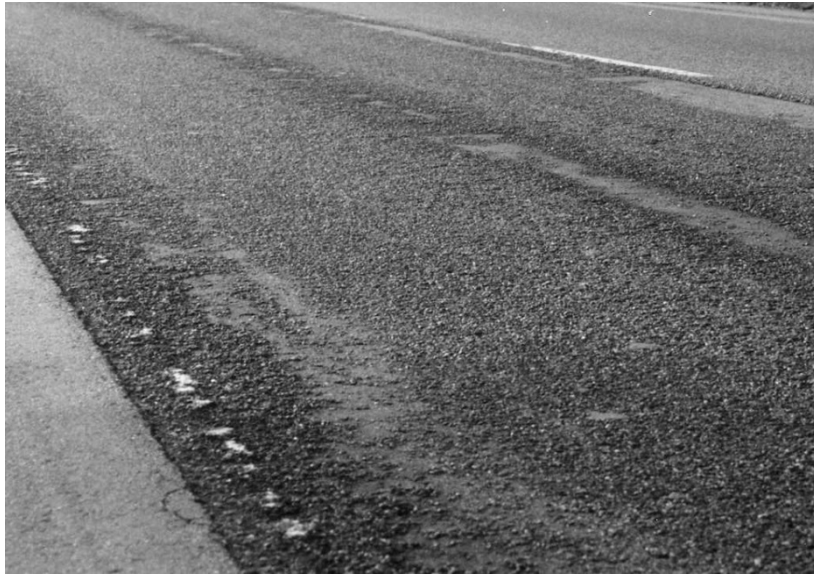
### Weathering and Raveling

One of the most common causes of asphalt deterioration is through weathering and raveling of a surface course. It is best described as a type of wearing of the surface course that causes the asphalt binder to break down forcing the small stones in the asphalt to dislodge. This can best be seen as a rough road surface.
